Title of Report: PW2022-052 Holstein Dam Safety Review
Department: Public Works
Branch: Transportation & Public Safety
Council Date: November 29, 2022

File No. 22234

November 17, 2022

TOWNSHIP OF SOUTHGATE HOLSTEIN DAM SAFETY REVIEW

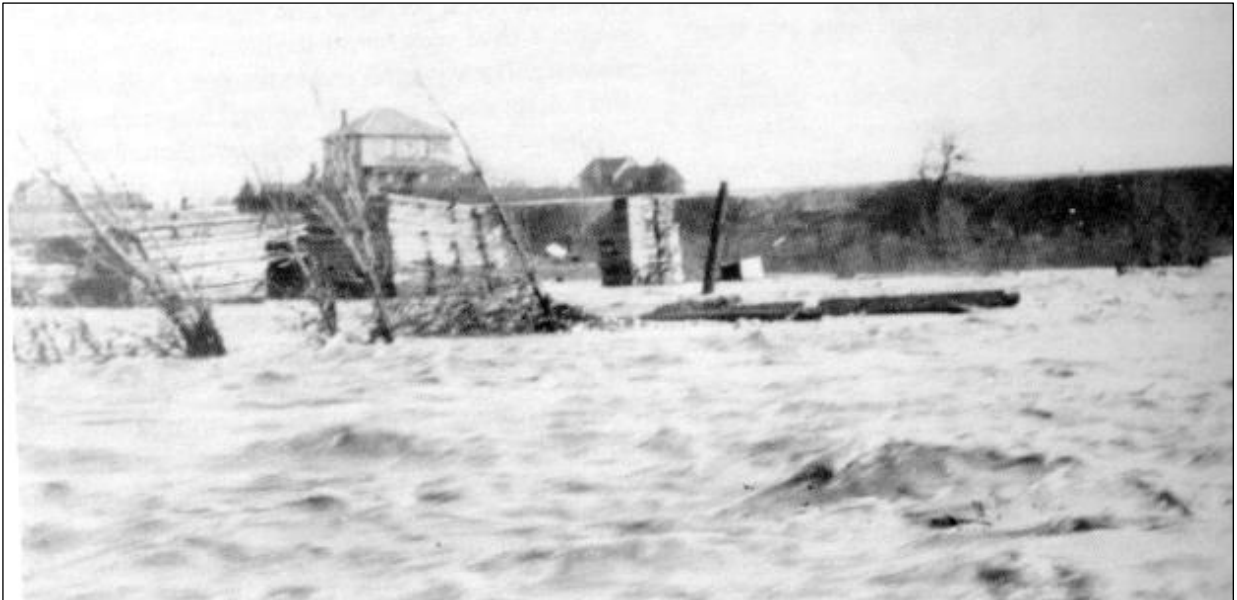
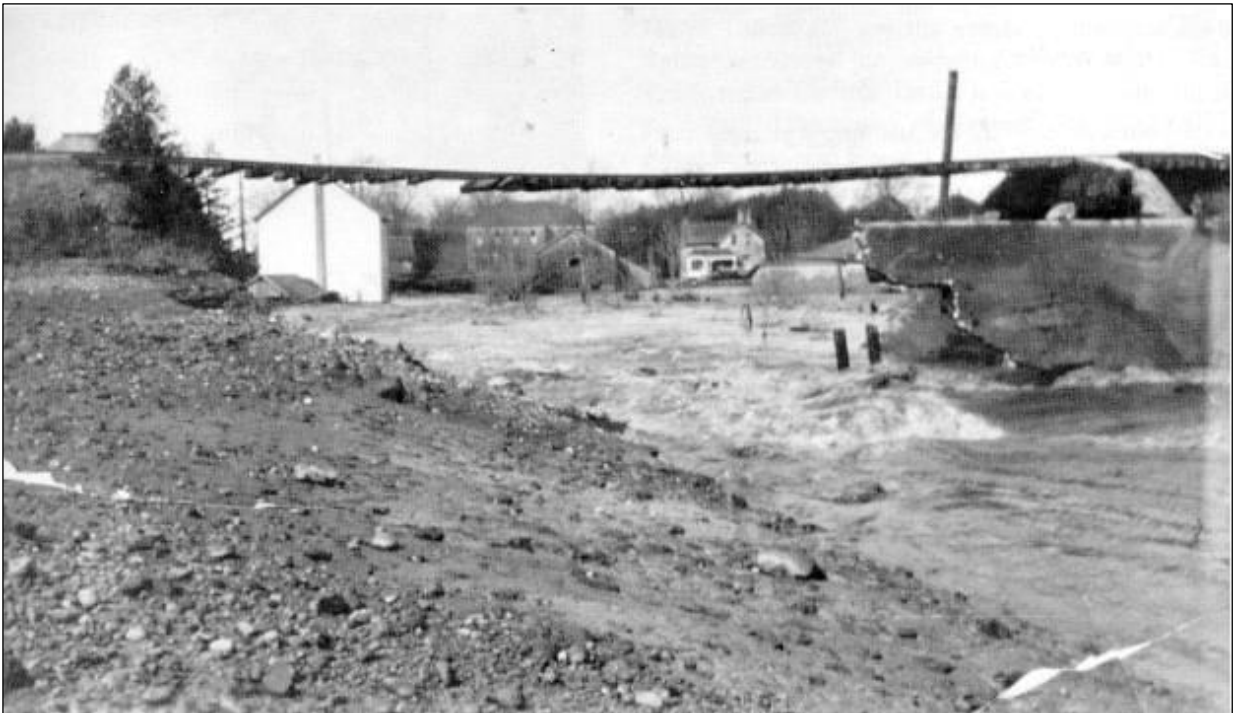
There are reports of a washout of the dam in 1929 and a minor washout in 1948. The photographs below are assumed to be from the 1929 event since the 1944 bridge is not shown.

The photographs show what appears to be timber cribbing and the remains of a broken concrete wall. It can be assumed that the existing concrete abutments of the spillway were constructed after the 1929 washout.

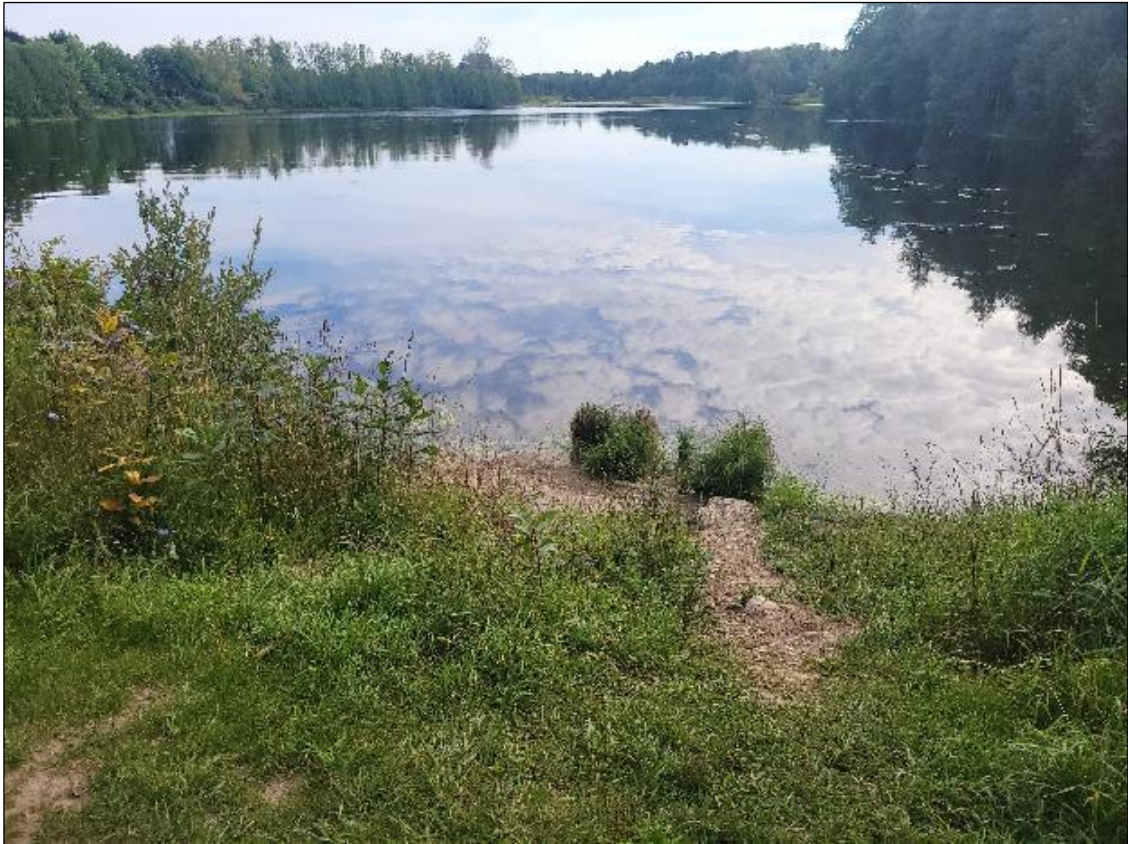
Head pond, looking east from dam

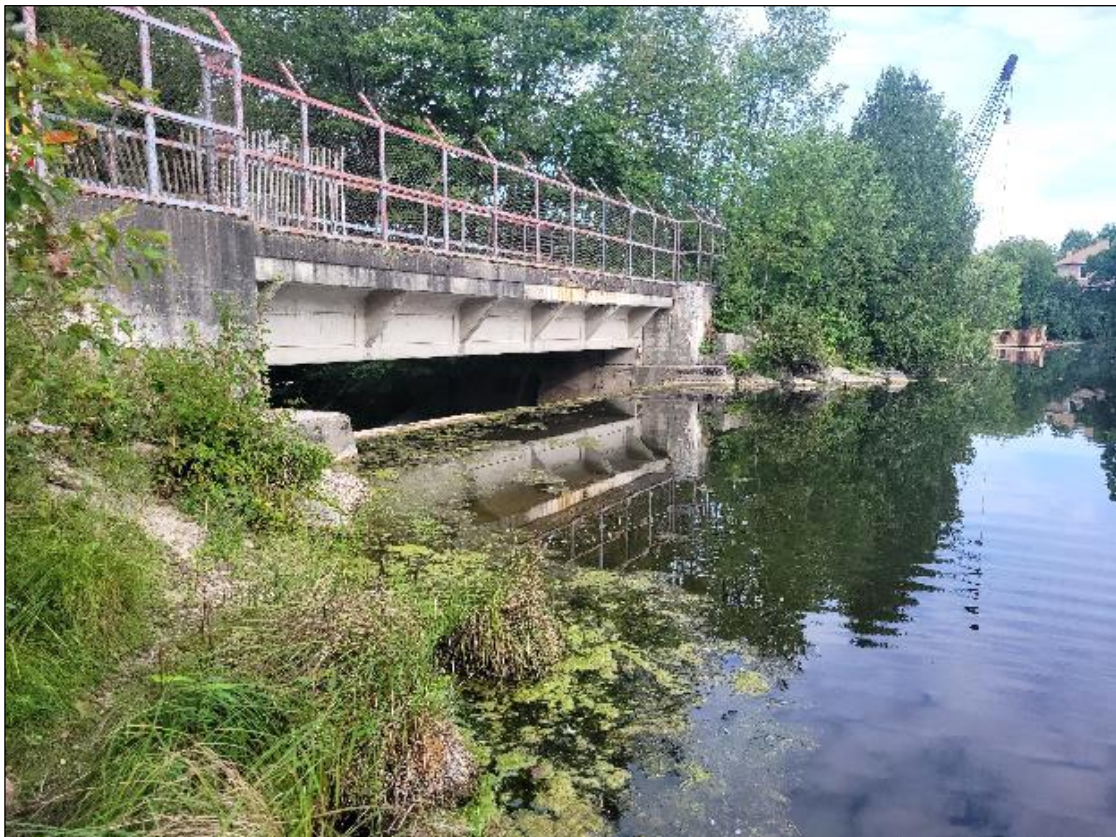
Upstream face of spillway

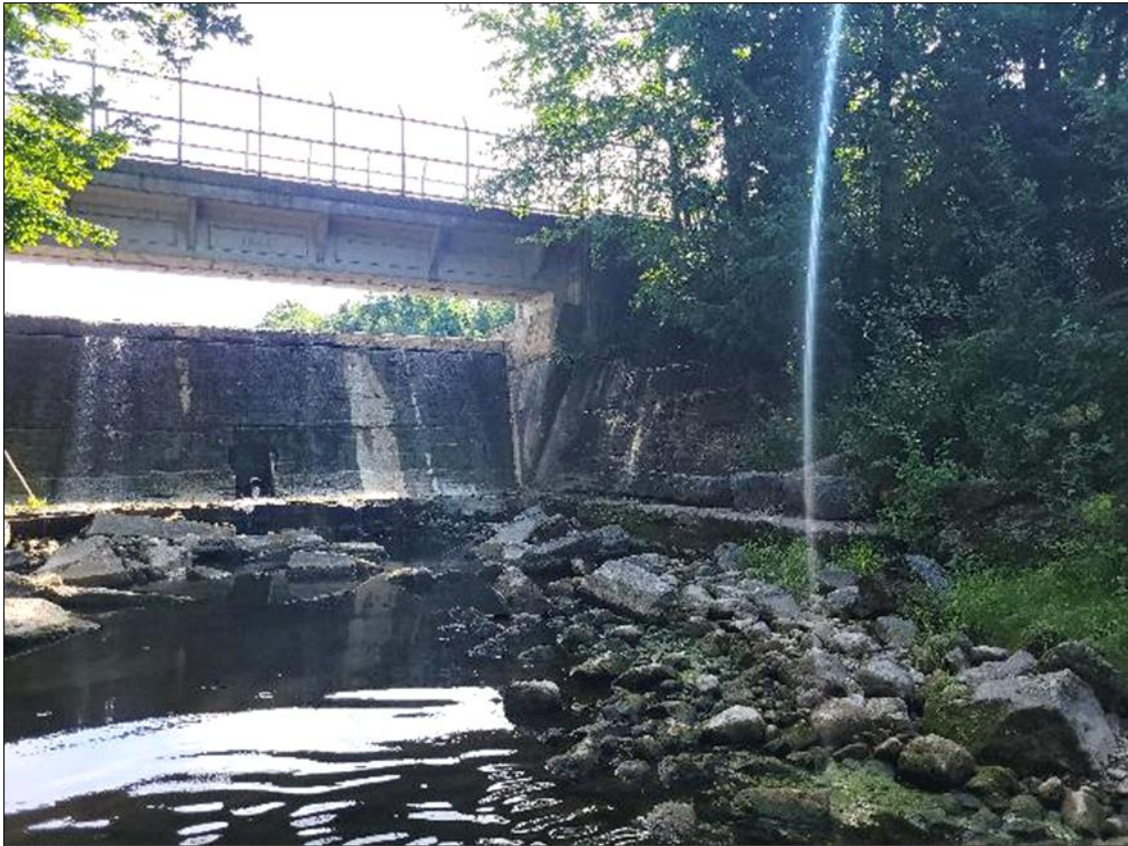
View of spillway and south abutment

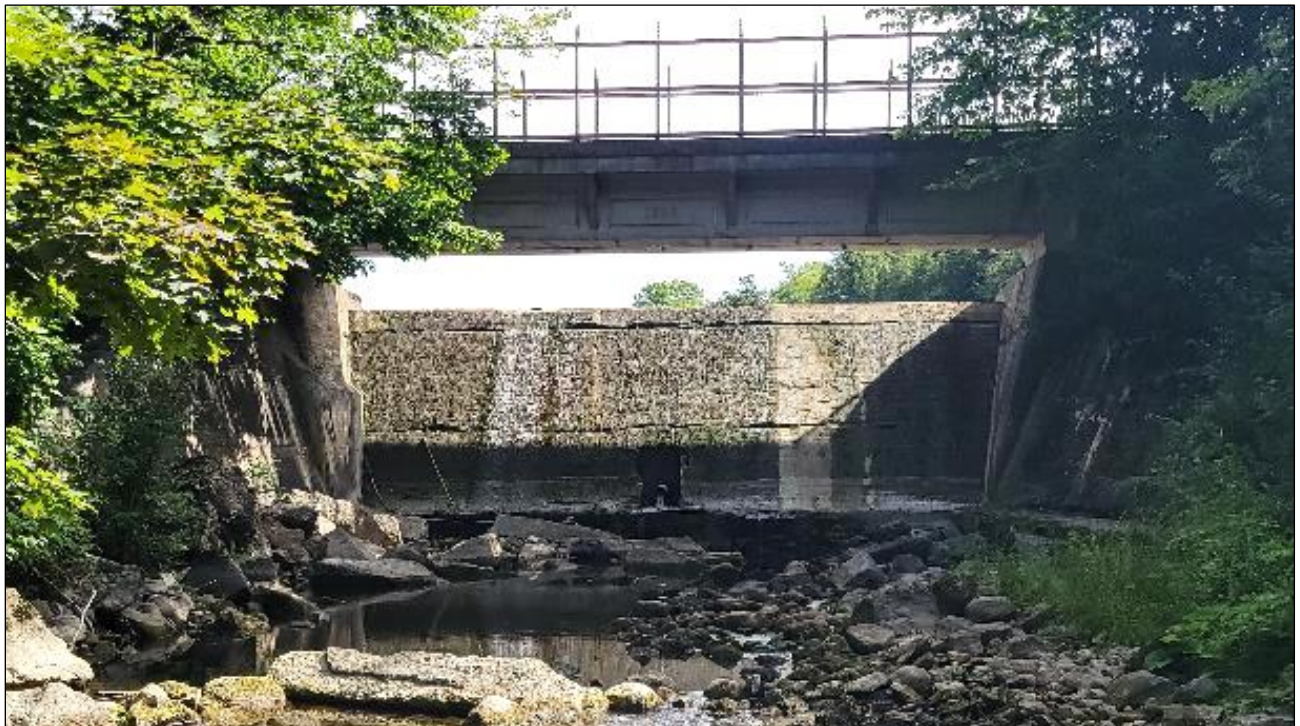
Looking upstream at spillway

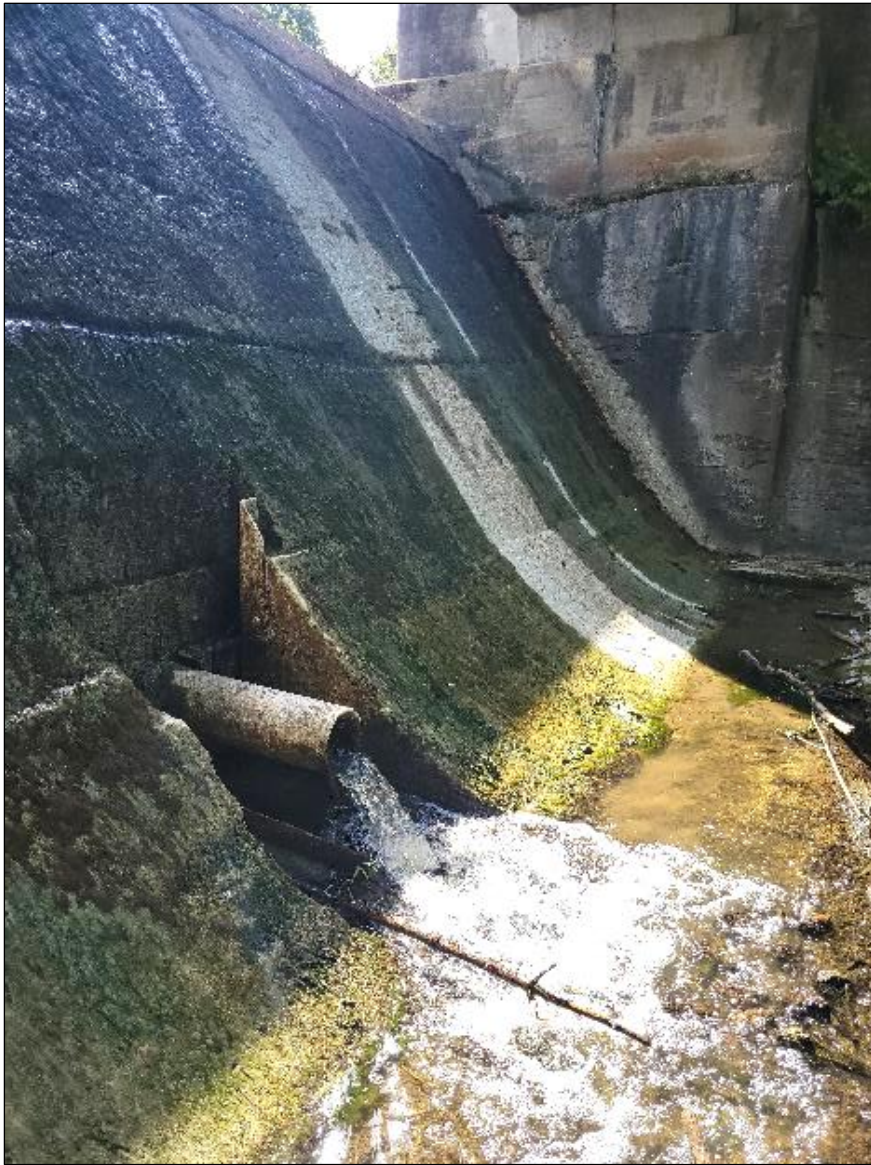
- Localized delamination north of low flow pipe.
- Area of spalled concrete north of low flow pipe.
- Some decayed timber planks and misplaced steel angle girders around low-flow pipe. These are likely part of a previous control and concrete formwork. They are of no consequence now.
- One area of sill, (location with flow over dam) had aggregate visible due to spalling.

Low flow pipe in spillway

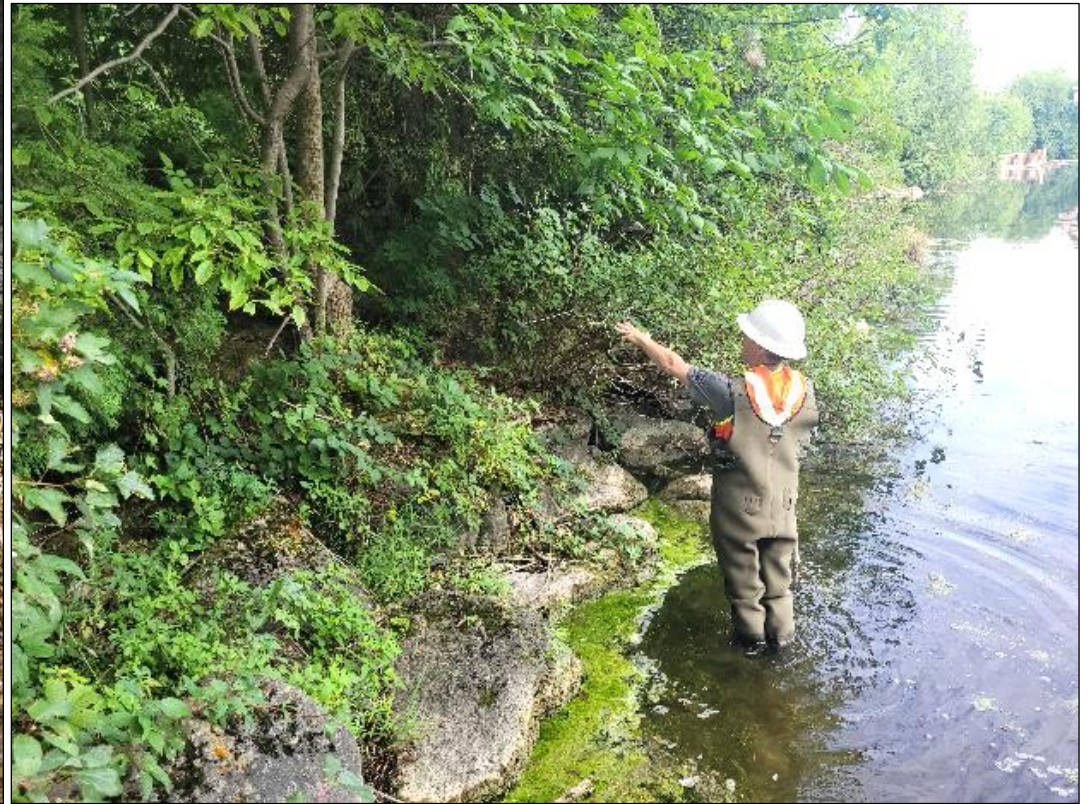
The upstream face of the earthen dam has a number of trees that pose a risk to the integrity of the dam. Trees can be uprooted during storms and the displaced root ball can compromise the effectiveness of the clay seal that prevents water penetration. As well, roots of larger trees can die, decay, and leave a conduit for water to pipe through the seal of the dam. It is recommended that trees be removed where their trunk diameter at 1 m above ground is more than 100 mm. The stumps or roots of the trees do not need to be removed.

Typical vegetation on upstream embankment

2. Repairs to Upstream Face of Berm**\$25,000**

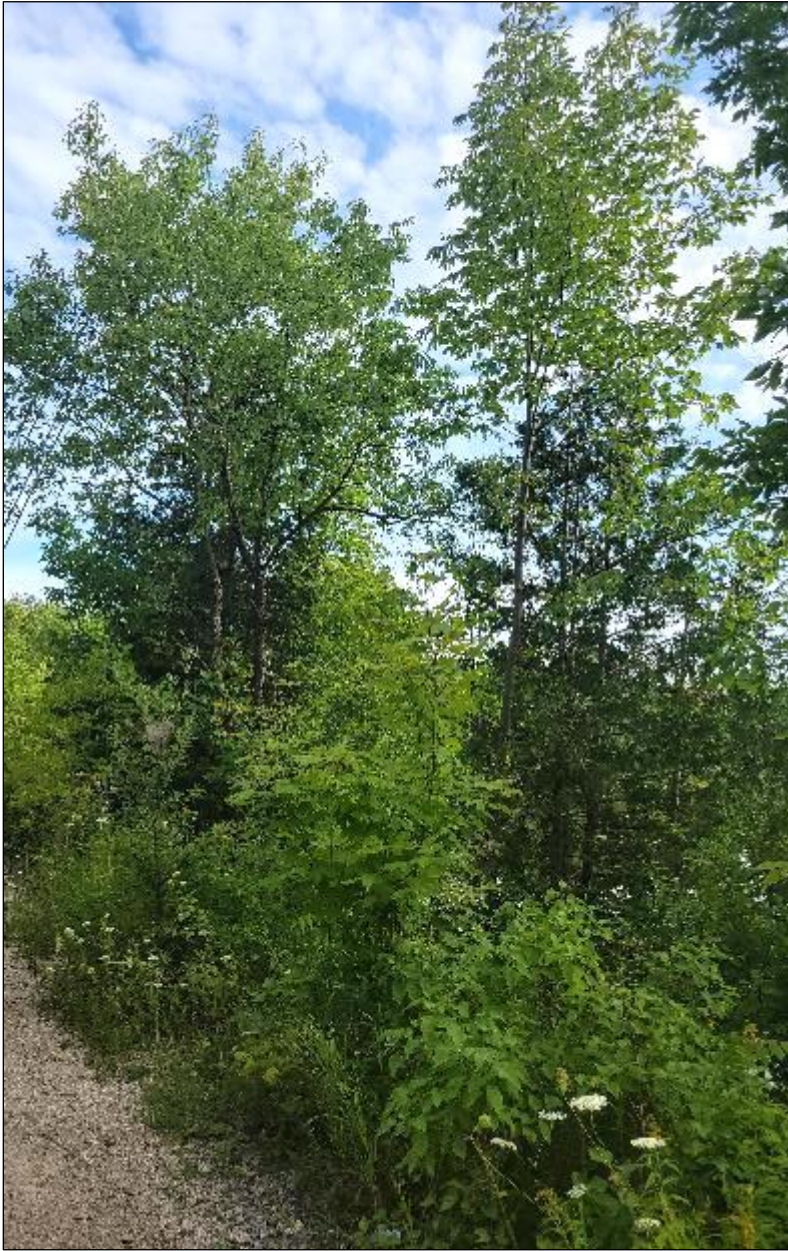
Typical vegetation on upstream embankment

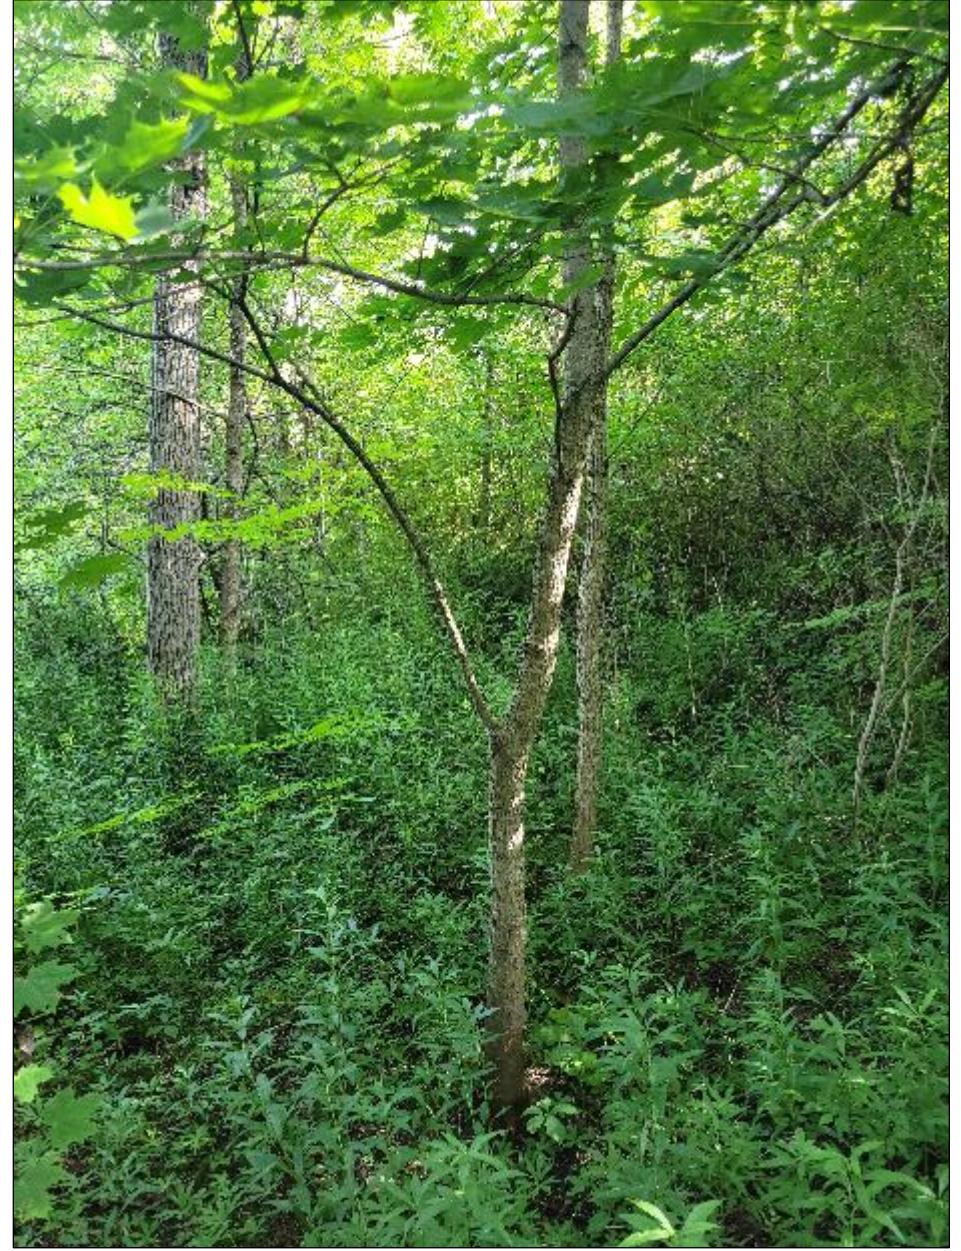
- The inspectors walked the embankment in an ‘X’ pattern.
- Some small rodent holes were observed.
- No major erosion issues were observed, but some small areas ($< 1\text{m}^2$) of sloughing were observed.
- No seepage was observed.
- There was water at the toe of the bank that was very slowly flowing towards the stream. The water appears to start in the area of the headrace into the mill. During the site visit, the cofferdam and the related construction work resulted in no water pressure at the sluiceway. A subsequent site visit to look for signs of obvious piping along the headrace should be conducted when there is water above the sluiceway gate.
- The embankment was heavily vegetated with trees and some shrubs. The largest tree was estimated to be 350 mm to 400 mm in diameter. The ground was bare in some locations due to the tree canopy.

Trees and shrubs on the downstream embankment

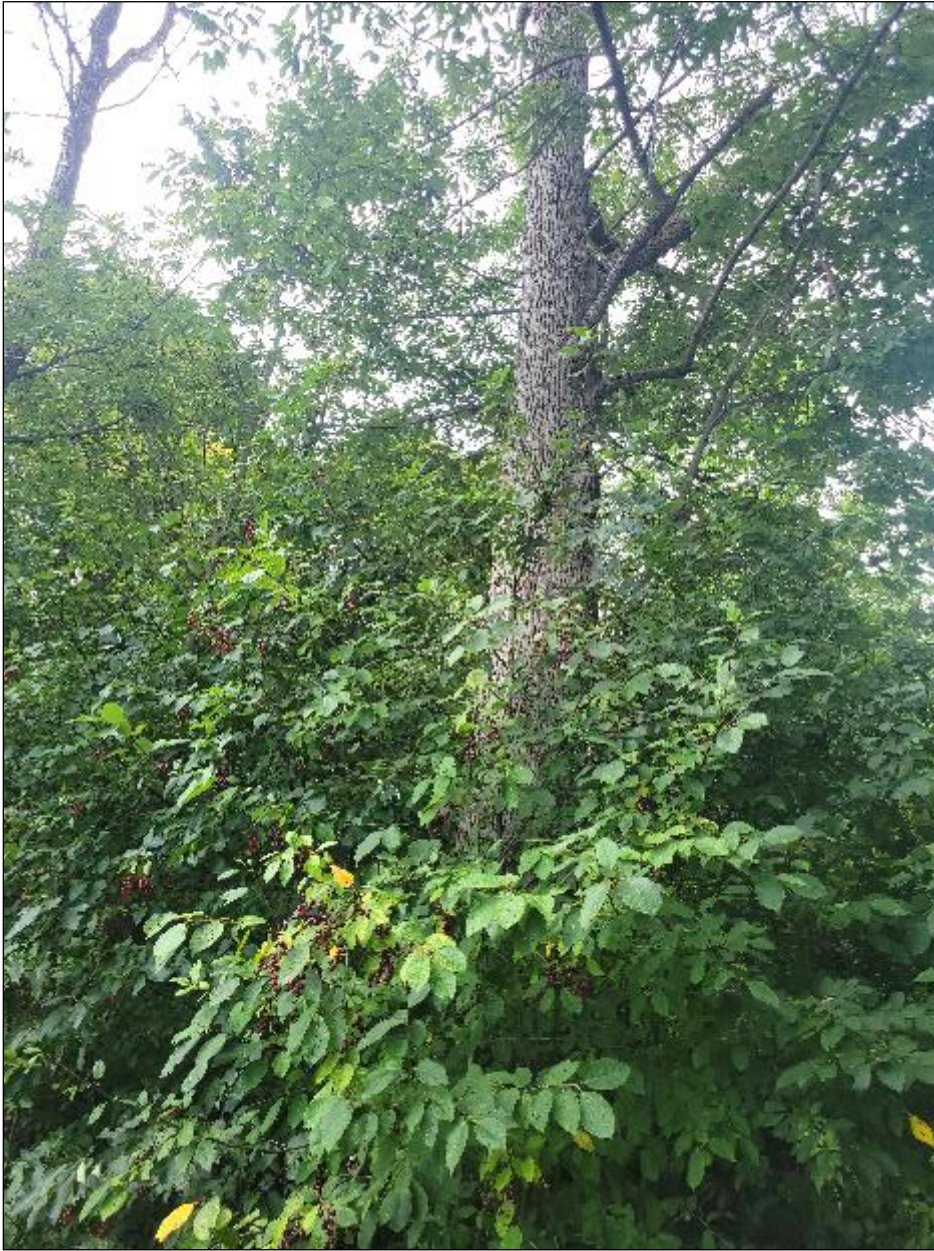
Larger diameter tree on downstream embankment (near spillway)

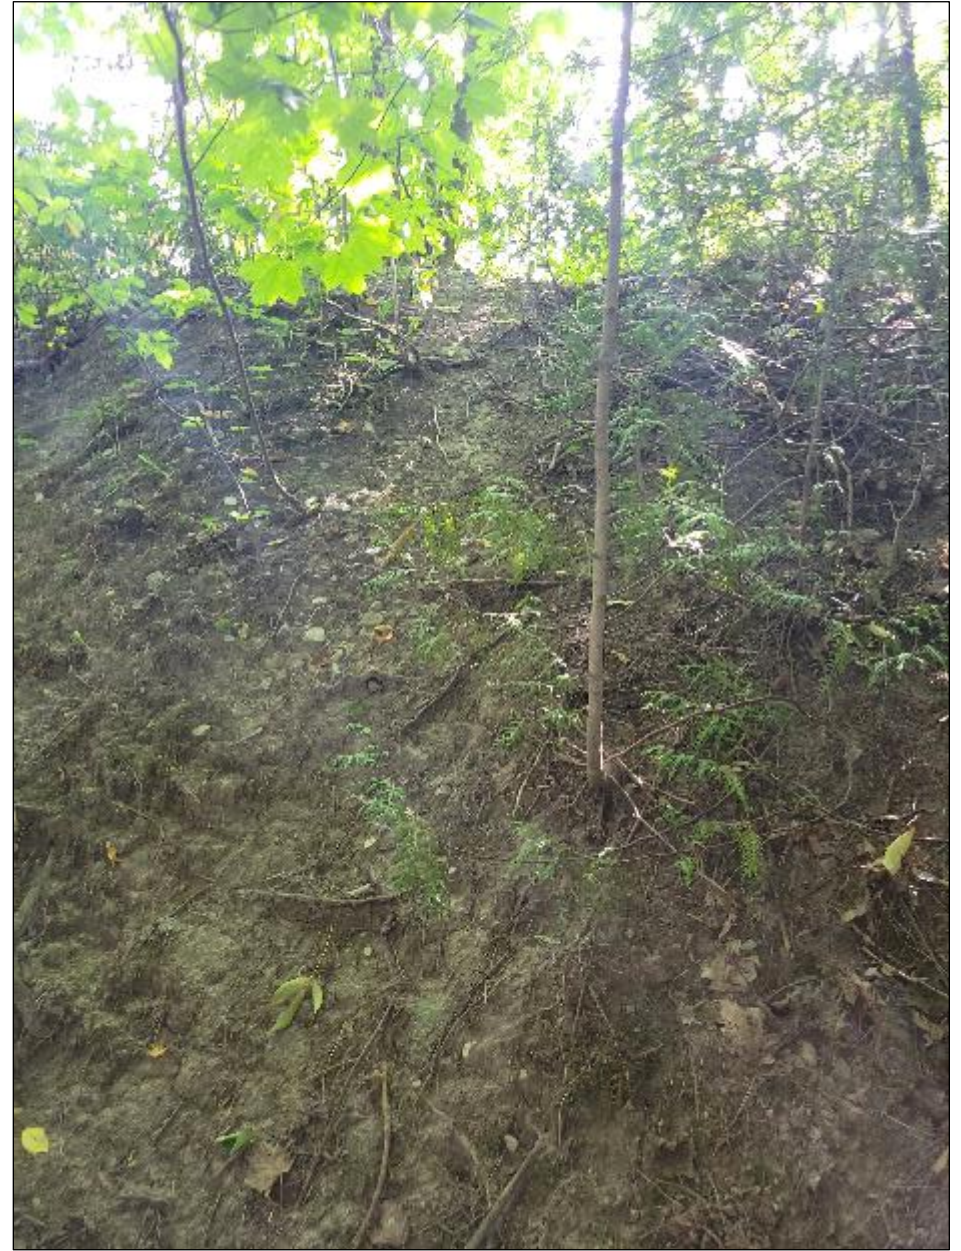
Downstream embankment with bare ground

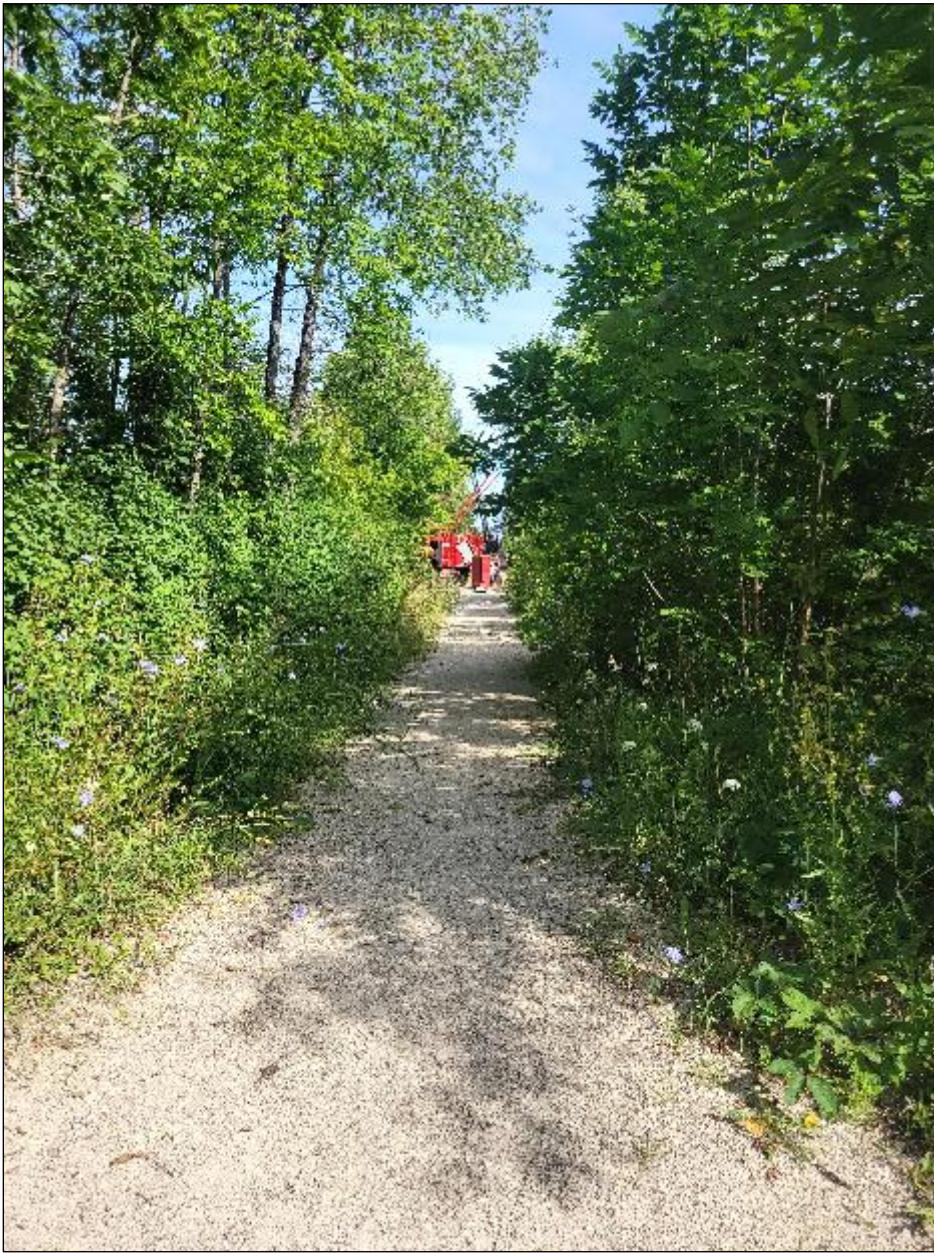
- The crest was a granular path that is used as a community trail.
- No erosion or settlement was observed.
- The crest is void of trees.
- No evidence of rills or overtopping.

Crest, looking north. Vegetation on both upstream and downstream embankments.

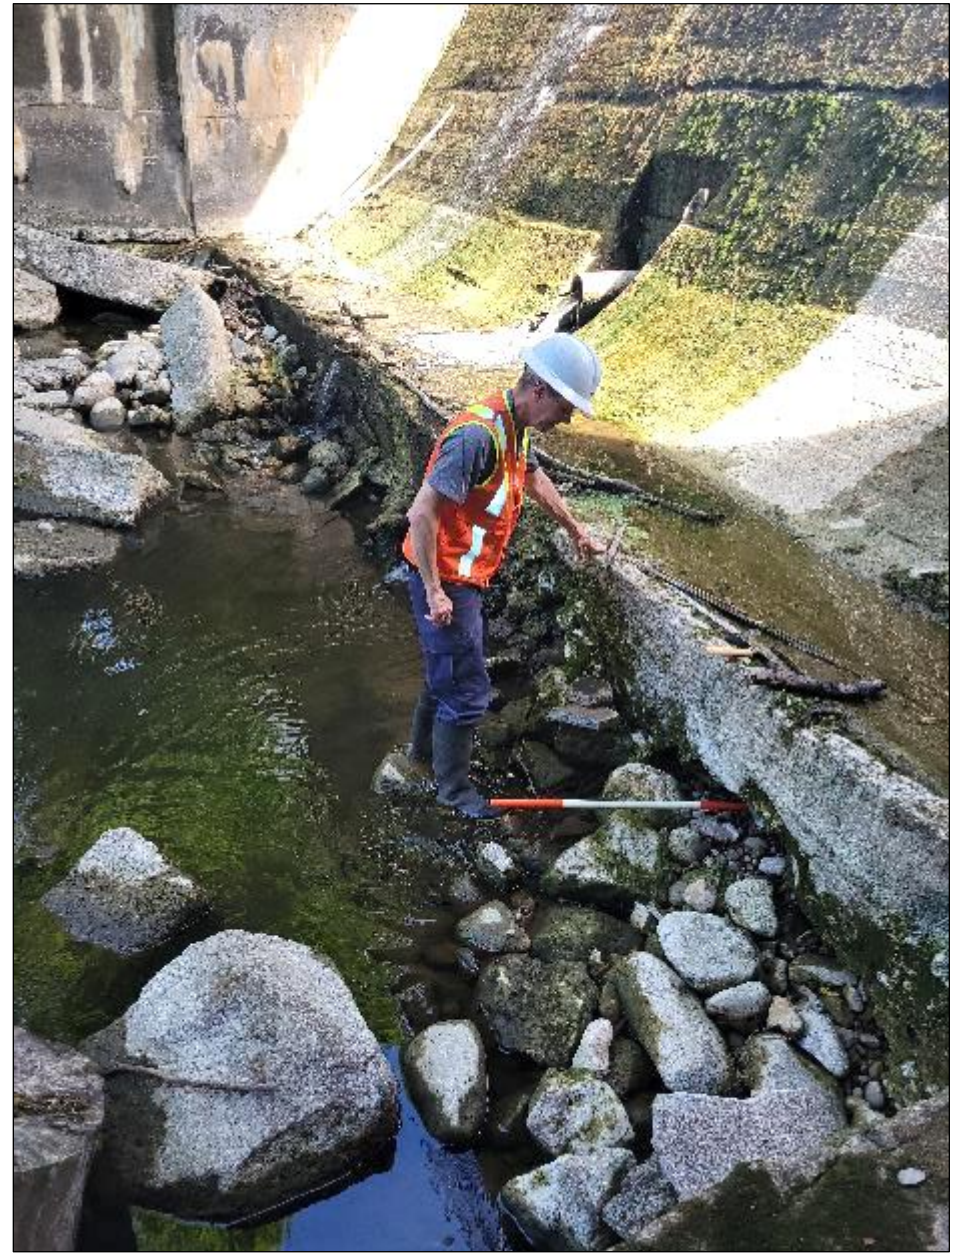
- The apron was undercut in one area (towards south) by 0.5 m.
- One decayed timber exposed, running E-W.

The footings of the two wingwalls and the spillway apron show signs of some scour and undermining. Although not severe at this time, the condition is likely to accelerate with each significant flow. It is recommended that a lean concrete grout be cast to fill the voids that exist under these foundations.

Undercut of spillway apron

1. Repair Spillway Footings

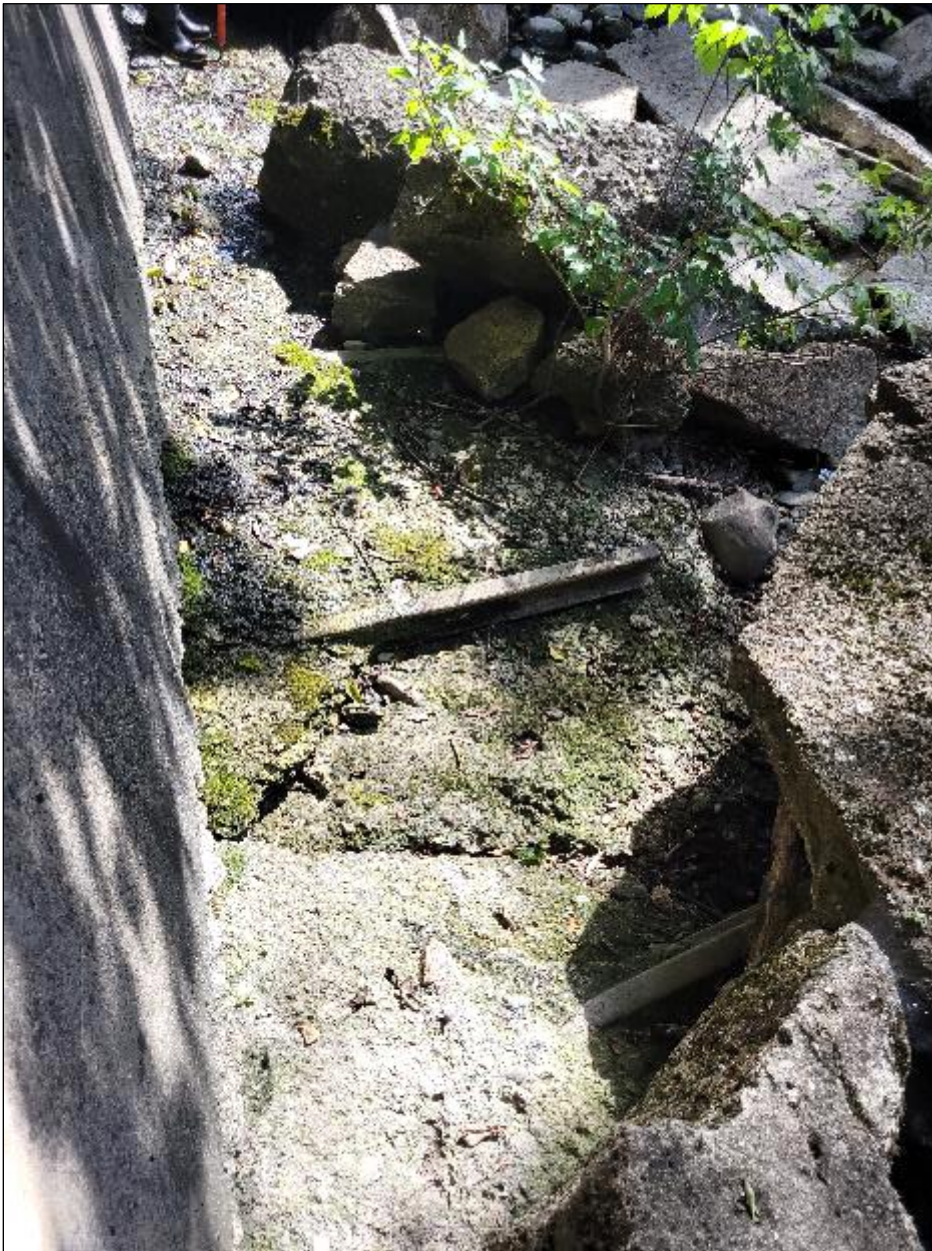
- Concrete about 90% fair and about 10% poor (delamination).
- Video taken during tap testing.
- The top of the apron/footing has been spalled or eroded and lateral lengths of steel rails are visible. Concrete missing from interface between wingwall bottom and top of apron.

North wingwall apron/footing with lateral lengths of steel rails visible

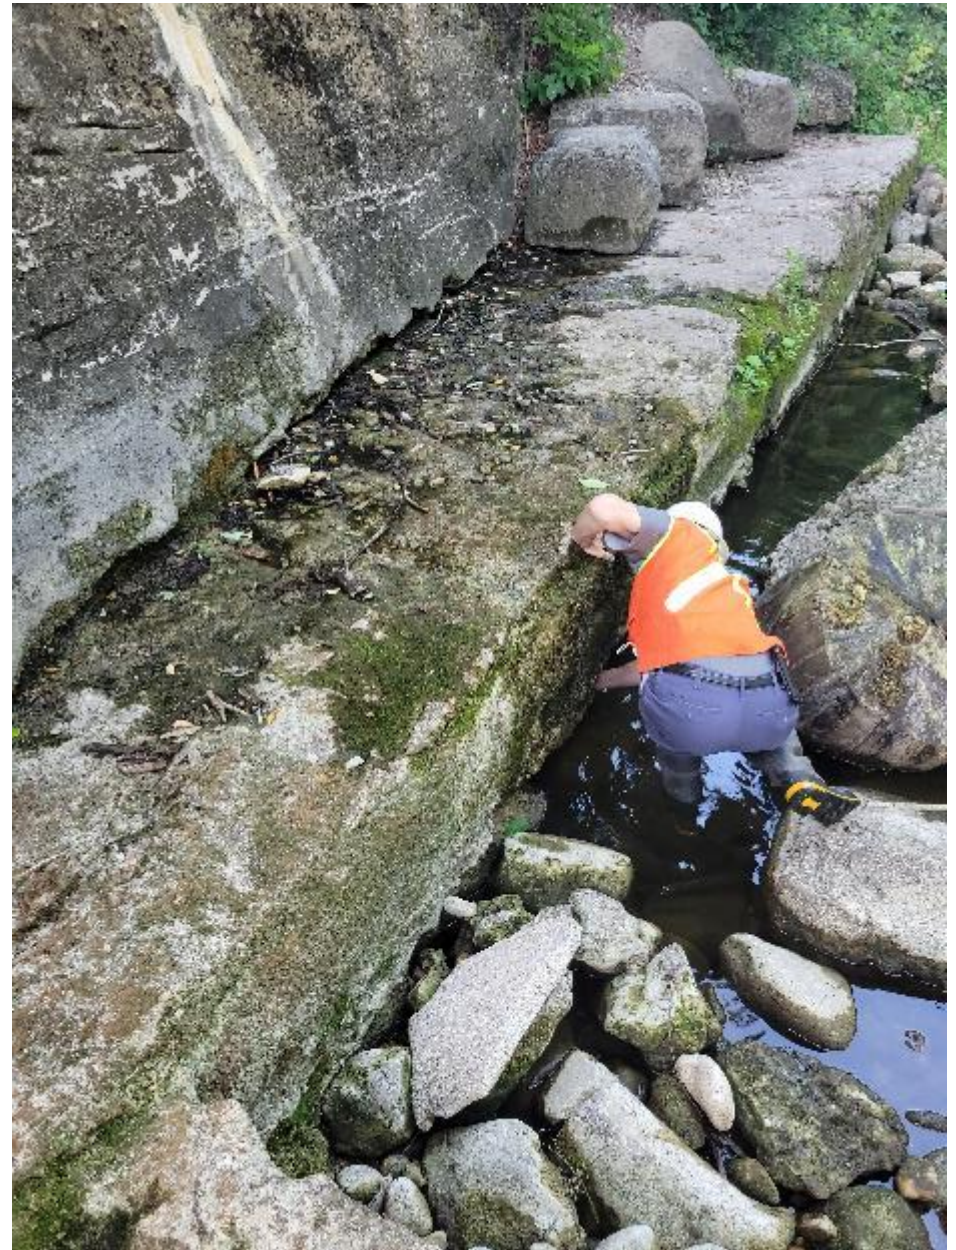
- The wingwall was undercut with concrete missing from the interface.
- Some delamination at the cold joint.
- The apron was undercut by more than 1.5 m.

South wingwall apron/footing undercut

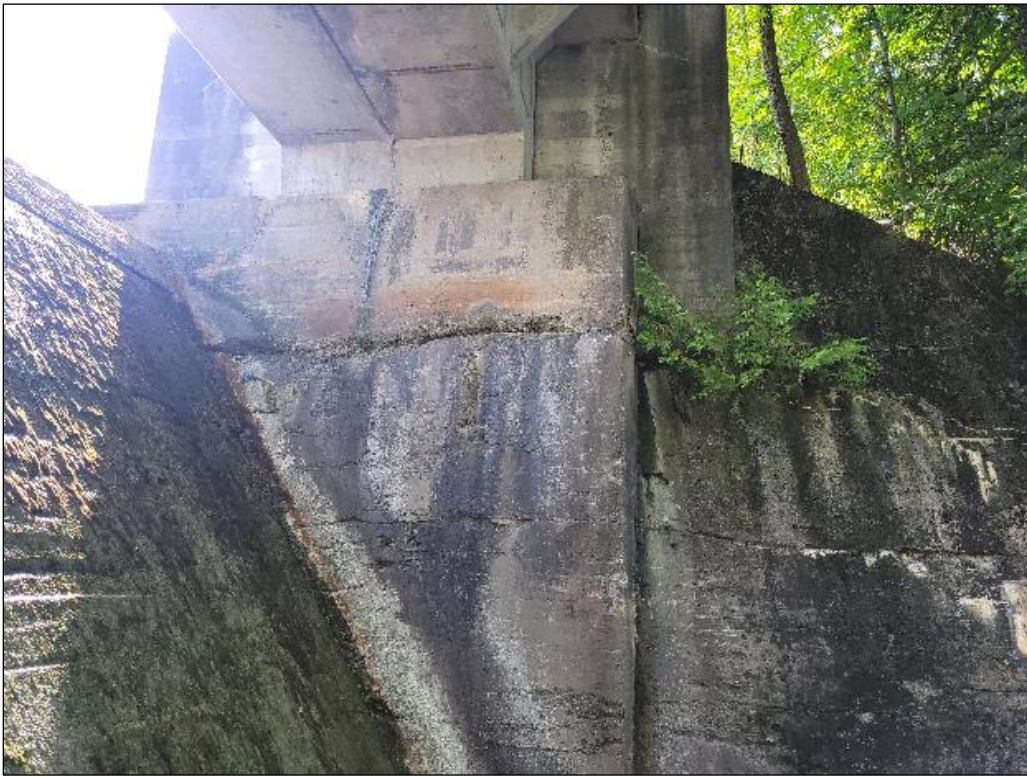
The exposed concrete faces of the spillway, abutments and wingwalls have spalls and delaminations that should be repaired to maintain the integrity of these structures in the long term. The work would involve providing access scaffolds or booms to reach all the affected areas. Unsound concrete would be chipped out and patches would be squared off, prepared, and cleaned. New concrete would be cast and cured in the voids. Mechanical anchorages would be used to fasten the new concrete to the existing base structure.

Abutment and south wingwall; Delamination at cold joint.

3. Repairs to Spillway Faces**\$65,000**

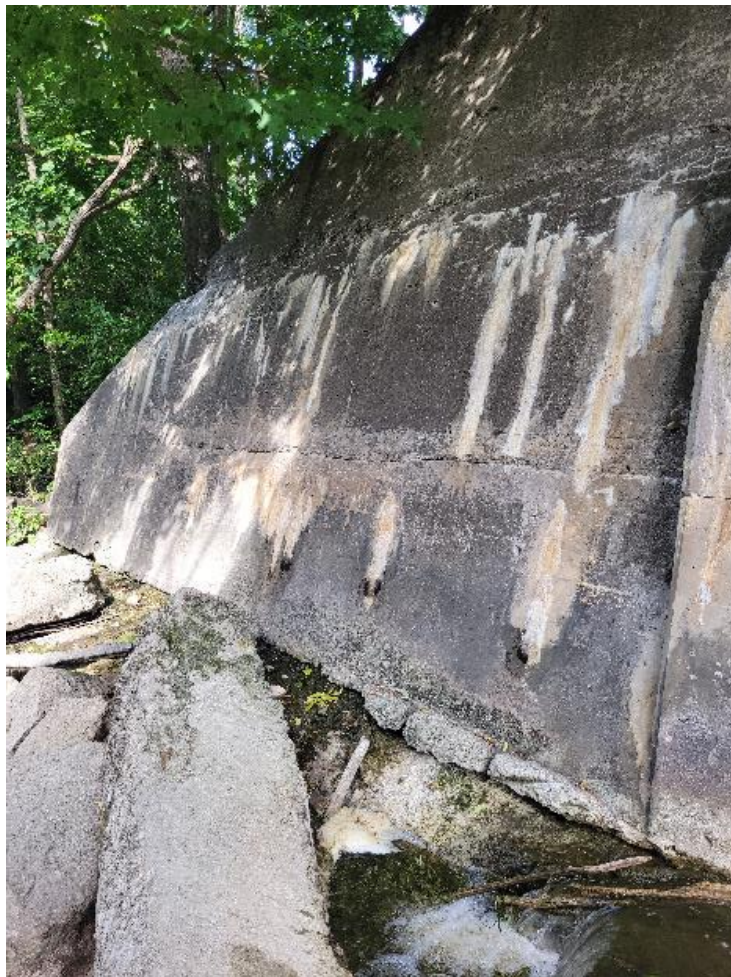
The gaps at the bottom of each wingwall face are also a concern for discontinuity between the concrete of the foundations and concrete of the walls. If the hidden reinforcing steel is insufficient or corrodes over time, there may be a risk of the walls kicking out or sliding over the top of the foundation. It is recommended that a reinforced concrete overlay be cast on the top of the wing foundations to fill the undercuts and provide an effective shear key to prevent displacement of the walls over their foundations.

North wingwall concrete missing from interface between wingwall bottom and top of apron
